# **BOWSER-MORNER. INC.**

#### **Field Service Report**

ENVIRONMENTAL AND GEOTECHNICAL SERVICES.

Westover Corp. Sanitary Landfill Site.

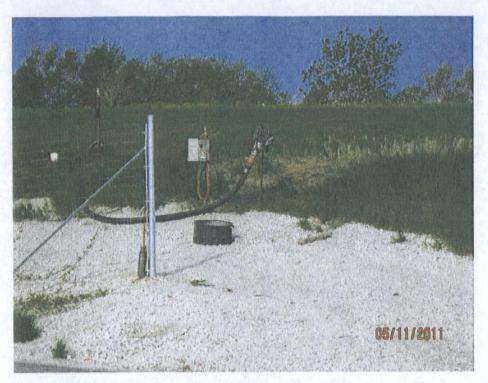
Photograph 1
Westover Landfill, main gate, east manhole. Note 3-inch hose and drip pan.

Leachate pumping was accomplished using a portable electric generator, heavy-duty submersible pump, 3-inch hose, and 4,000-gallon tank truck from May 4 through June 2, 2011. The truck was originally identified as having a 5,000-gallon tank, but was later correctly identified as having a 4,000-gallon tank, which caused a field reporting error in the first two loads.

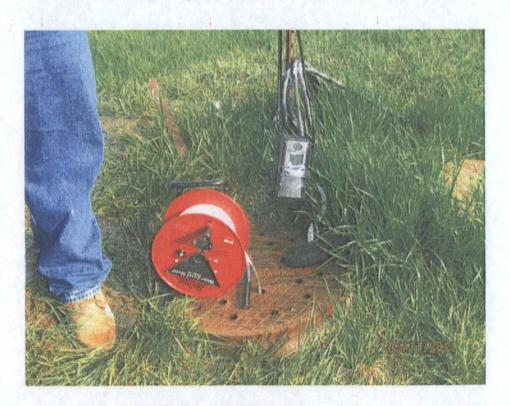
Photograph 2 Water level meter and four gas meter at east manhole.

Methane concentrations were continuously monitored at the east manhole during leachate pumping and were not above the 10 percent lower explosive limit (LEL). Methane gas concentrations were also periodically monitored at the metal pipe during leachate pumping.

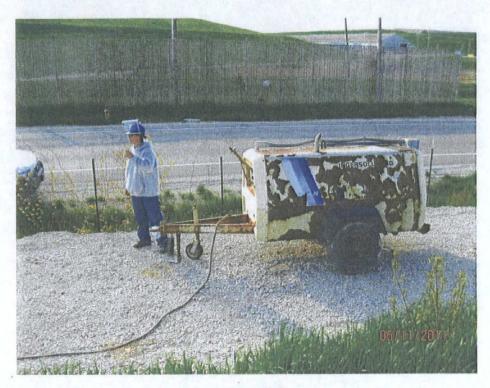
Photograph 3
Generator for 3-inch submersible pump.

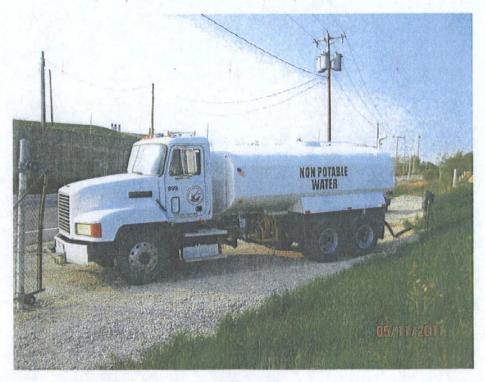
Photograph 4
Geo. Gradel Co. 4,000-gallon tank truck (side view).

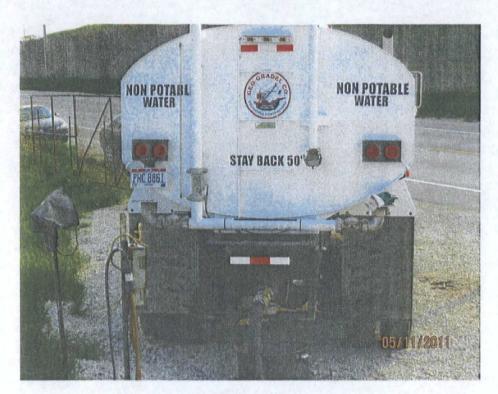
Photograph 5
Geo. Gradel Co. 4,000-gallon tank truck (rear view).

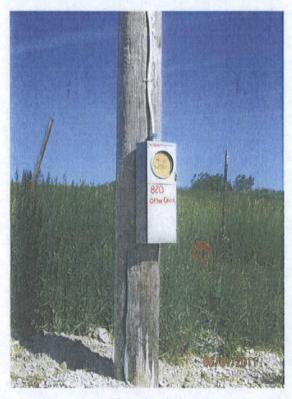
Photograph 6
Utility pole with inspected meter base proximal east manhole.

A utility pole (No. 5839) and electrical box were installed proximal the east manhole on May 20, 2011. The electric box was inspected by the City of Oregon and passed on May 31, 2011. The electric meter base was installed and final connection completed on June 17, 2011.

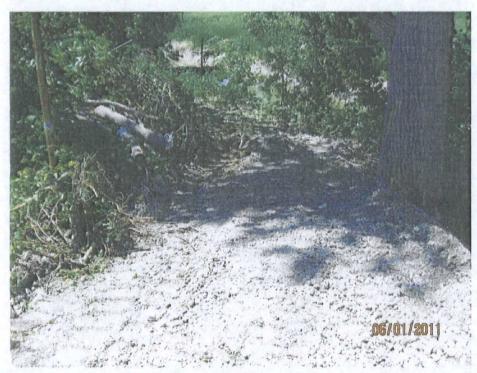
Photograph 8 South view of path leading to metal pipe.

BMI representatives observed Gradel representatives clearing brush to access the metal pipe on May 25, 2011. Metal pipe repairs were observed by Mr. Gulch, Mr. Ryan Green of Weston, and Mr. Kiger on June 1, 2011.

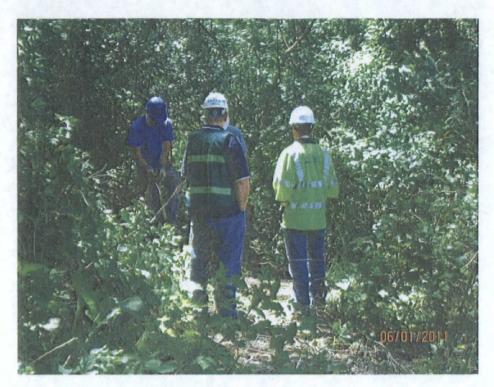
Photograph 9
USEPA and S. T. A. R. T. consultant observing metal pipe excavation.

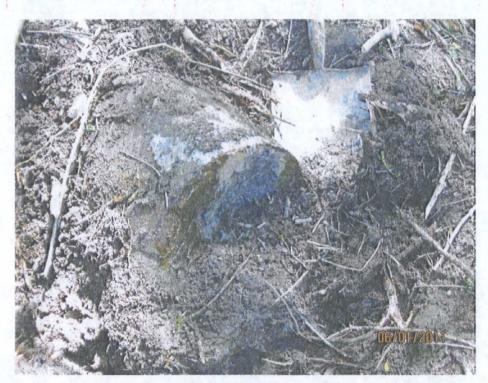
Photograph 10
Beginning of metal pipe excavation. Note absence of leachate.

Metal pipe repairs consisted of over-excavating the metal pipe mouth, attaching a flexible connector, attaching a pre-fabricated metal cap, and encasing all in an approximately 40-inch cube of Ohio Department of Transportation (ODOT) Class C Concrete. Metal pipe repairs were carried out as per the Plan and Plan Figure 1. The metal pipe mouth over-excavated soils appeared to be lean clay (as specified by the historical closure plans) and were contained in two full and two partially full 55-gallon drums.

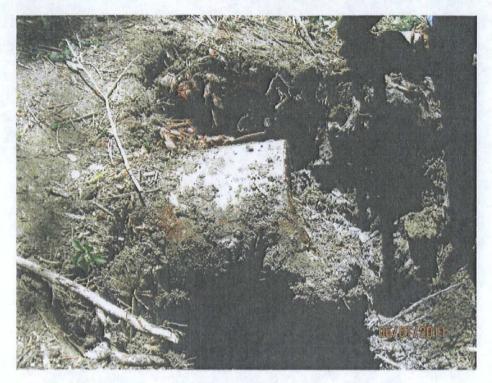
Upon over-excavating the metal pipe mouth, it was observed to contain a historic concrete plug, which had "bulged" a volume of concrete into the 7 o'clock position. During over-excavation, the concrete bulge was impacted by hand- shovel and a small diameter, but continuous trickle, of leachate emerged.

Photograph 11 Continuation of metal pipe excavation. Note concrete "bulge" at 7 o'clock position.

The bulged concrete needed to be removed for installation of the flexible connector and metal cap; however, there was concern for a larger leachate release. Therefore, in consultation with Mr. Gulch, it was decided to eliminate the flexible connector and metal cap and directly encase the metal pipe mouth in concrete.

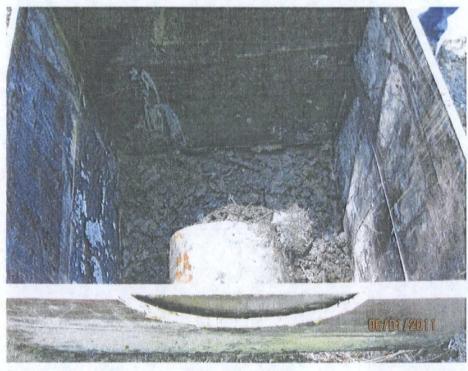
Photograph 12 Formed metal pipe excavation. Note concrete "bulge" at 7 o'clock position.

As such, the metal pipe over-excavation was completed, and a plywood form approximately 40 inches square was erected and the metal pipe mouth was encased in approximately 1-1/3 cubic yards of ODOT Class C concrete.

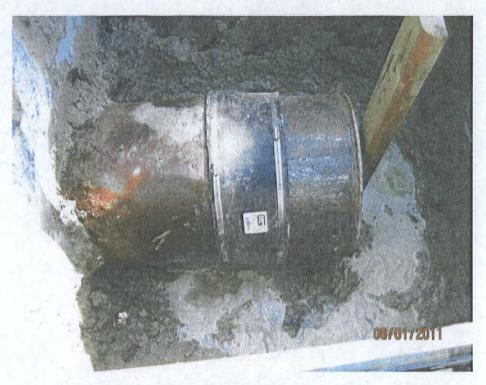
Photograph 13

During flexible connector and metal cap installation approximately less than one gallon of leachate expressed into the bottom of the formed over-excavation. This leachate was incorporated using hand tools into the emplaced ODOT Class C concrete.

Metal pipe with flexible coupling and metal cap installed. Note relatively small amount (<1 gallon) of leachate.

Subsequently, the recently formed "green" concrete was removed, the metal pipe mouth exposed, the bulged portion of the historically concrete plug removed, the flexible connector and metal cap installed, the form reinforced, and another batch of approximately 1-1/3 cubic yards of ODOT Class C concrete placed.

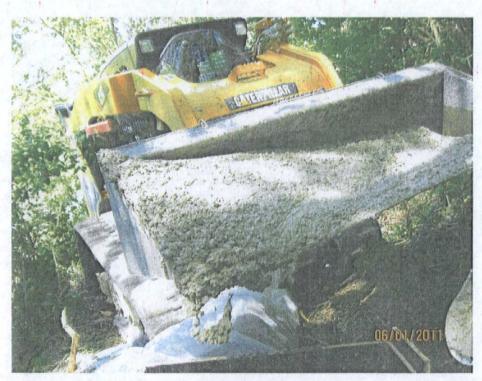
Photograph 16 "Bobcat" dropping concrete into form.

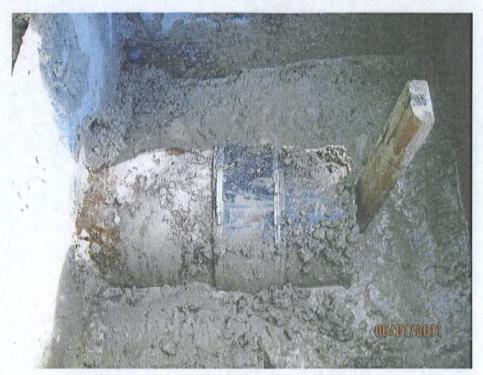
Photograph 17 Concrete in form partially surrounding metal pipe, flexible coupling, and metal cap.

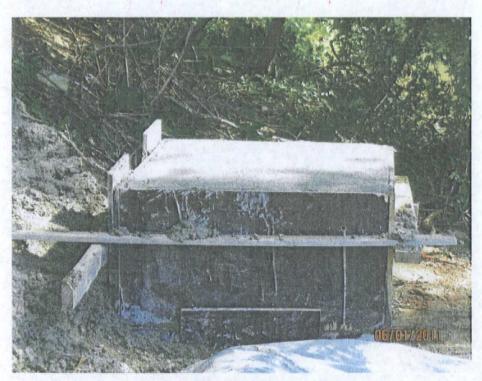
Photograph 18
Metal pipe repairs within formed concrete.

The newly-laid concrete was finished and no leachate was observed migrating through the concrete top or out the form edges. The two full and two partially full 55-gallon drums containing soil were transported via "bobcat" to old Millard Avenue and sampled per the Plan.

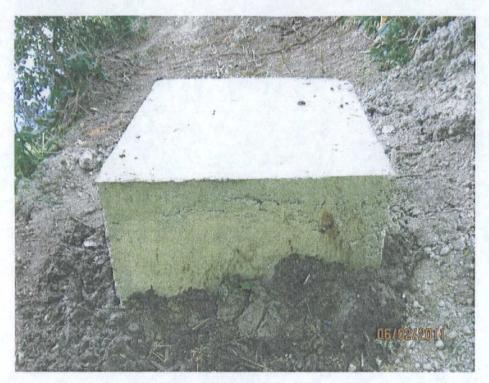
Photograph 19 Completed metal pipe repairs (north view).

The metal pipe at the northeast corner of the landfill was successfully capped and encased in approximately 1-1/3 yards of ODOT Class C concrete. Subsequent field observations indicate no leachate leaking from the capped and encapsulated metal pipe.

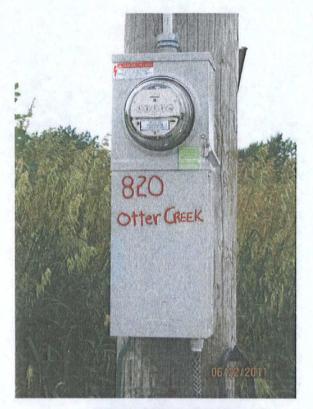
Photograph 21 Completed electrical service.

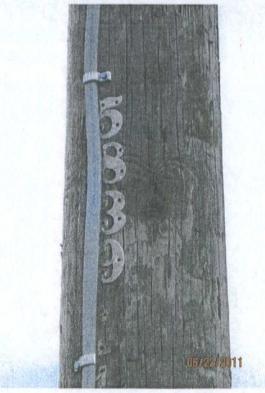
Photograph 22 Utility Pole No. 5839.

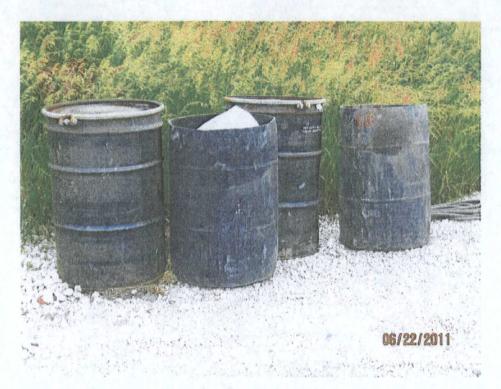
Photograph 23 Staged drums proximal east manhole.

The two full and two partially full 55-gallon drums of soil were staged proximal the east manhole behind the locked gate. The soil samples were transported to Jones & Henry and tested for volatile organic compounds (VOCs), semi-volatile organic compounds (SVOCs), and Resource Conservation Recovery Act (RCRA) metals.

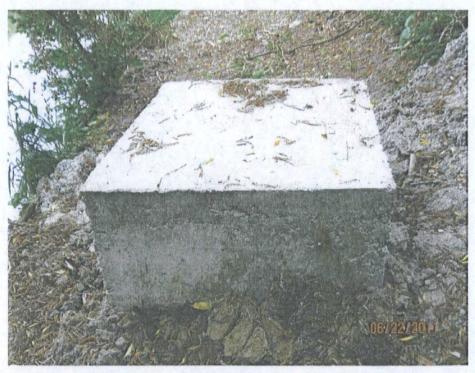
Mr. Kiger observed the metal pipe repair to be free of leachate leaks on June 3, 6, and 22, 2011.

Photograph 24
Final observation of repaired metal pipe. No leachate noted.

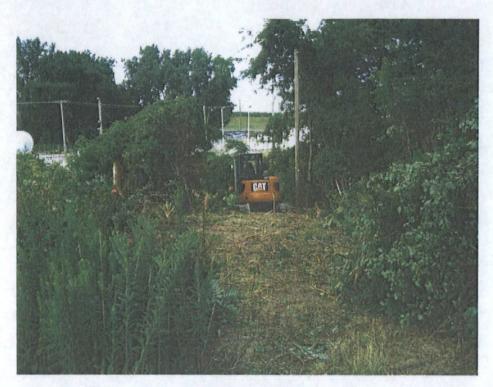
Photograph 27 Clearing access to concrete culvert,

As performed by Gradel and observed by BMI, the concrete culvert was improved on August 3, 2011. The larger piece of concrete culvert was removed. Soil over the top of the 30" concrete culvert was removed. The joints of 30" concrete culvert were tightened. The top of the 30" concrete culvert and the bottom of the ditch from the culvert to Otter Creek were topped with geotextile material and covered with approximately 20 tons of 4 x 8 inch crushed limestone rip-rap. Back on top of the 30" concrete culvert, the soil was replaced and graded to re-form the easement back up to the utility pole.

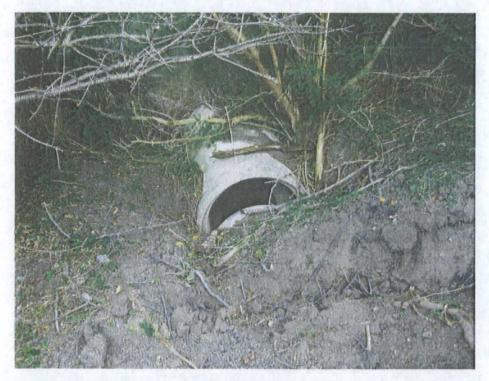
Review of the OEPA approved Westover Landfill plans indicates Otter Creek Road stormwater runoff drains into a ditch that flows along the south edge of the landfill, through a 30" concrete culver and into Otter Creek. When Weston conducted their original sampling and field observations, they indicted that the concrete culvert was broken. The subsequent US EPA Consent Order mandated concrete culvert repairs.

Photograph 28
Overview of larger and smaller concrete culvert.

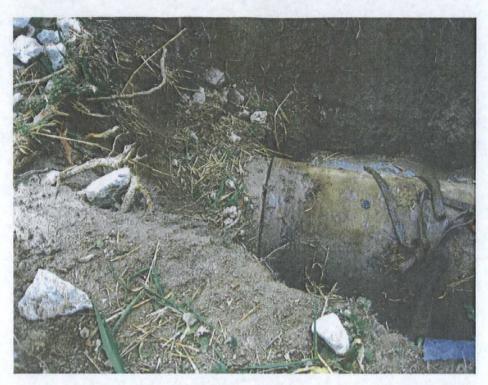
Photograph 29
Tightened concrete culvert joint.

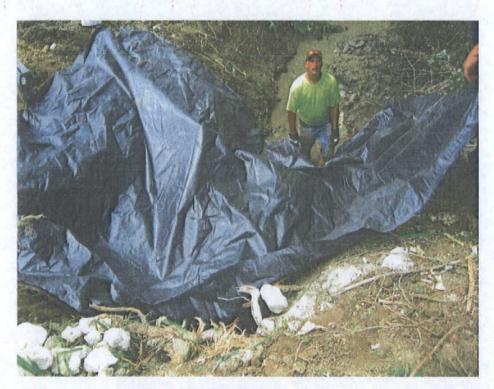
Photograph 30 Spreading geotextile over culvert top and ditch bottom.

The 30" concrete culvert was torn apart and reconstructed to be better than originally designed with the addition of geotextile fabric and 4 x 8 inch crushed limestone rip-rap.

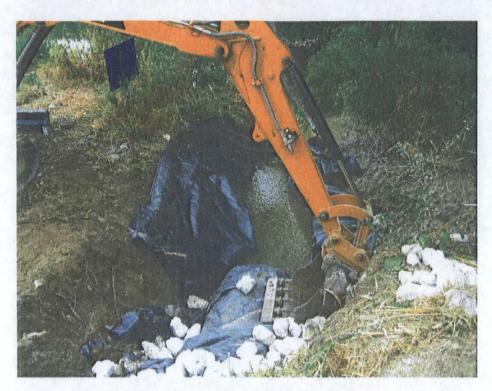
Photograph 31
Anchoring and compacting geotextile material.

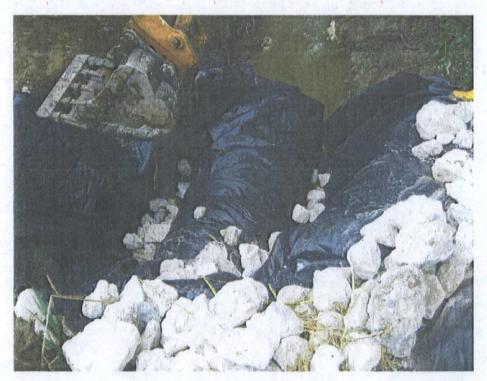
Photograph 32
Placing rip-rap over concrete culvert.

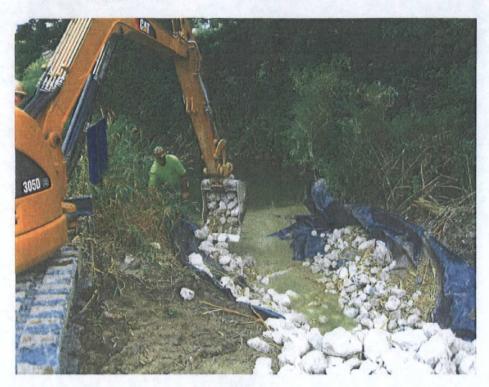
Photograph 33 Placing rip-rap over ditch bottom.

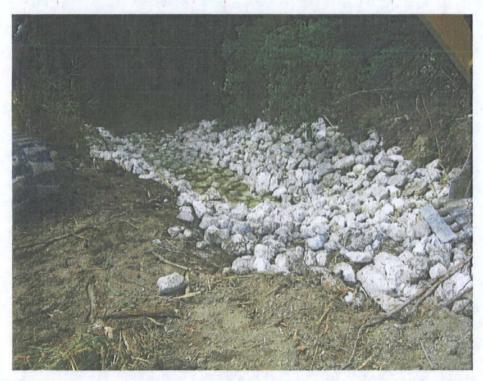
Photograph 34
Completed rip-rap over culvert top and ditch bottom.

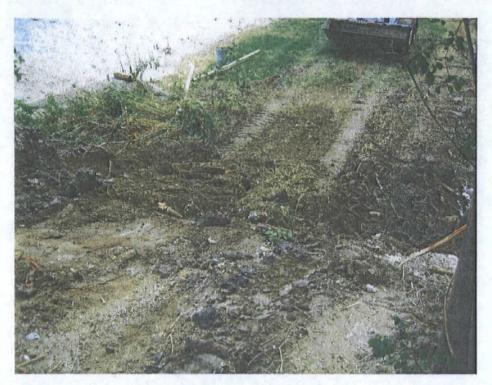
Photograph 35
Grading easement over concrete culvert.

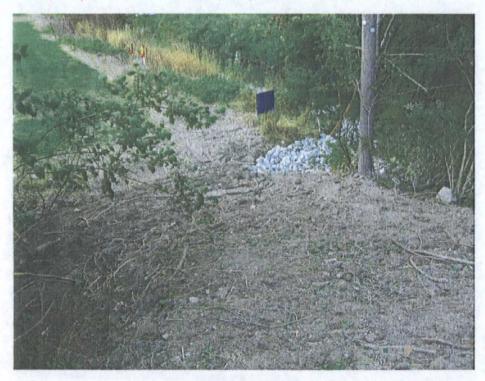
Photograph 36
Completed easement over concrete culvert.

Although not required by the Plan, Mr. Gulch suggested grass seeding the graded easement soil over the 30" concrete culvert and eliminating two metal mowing obstacles from the top of the landfill. Subsequently, as performed and observed by Gradel, the easement graded soils were grass seeded with straw cover, and the two metal mowing obstacles were removed on August 30, 2011.

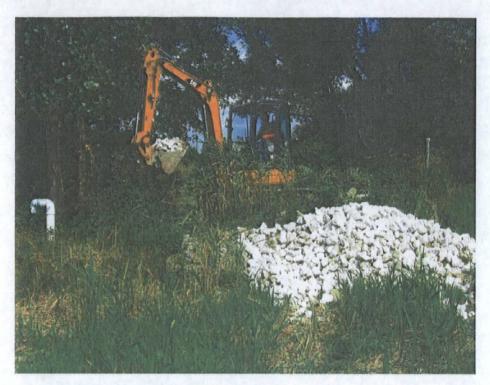
Photograph 39
Rock letdown during improvements (typical).

Review of the OEPA approved Westover Landfill plans indicates there are three rock letdowns (south, central, and north) along the west side of the landfill. BMI field observation indicates that there also was an area of broken concrete around a methane vent at the southeast corner of the landfill. As performed by Gradel and observed by BMI, the area proximal the southeast methane vent and the three rock letdowns were cleared of brush or bushes, dressed with additional 40 tons of 4 x 8 inch crushed limestone rip-rap, graded, and compacted on August 5, 2011. As reported by Gradel, approximately 10 tons of rip-rap was emplaced at each location.

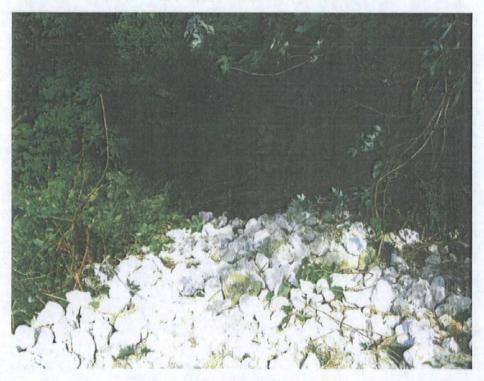
Photograph 40
Rock letdown after improvements (typical).

The rock letdowns were refurbished to be as good as originally designed, and the area proximal the southeast methane vent was upgraded to be better than originally designed.

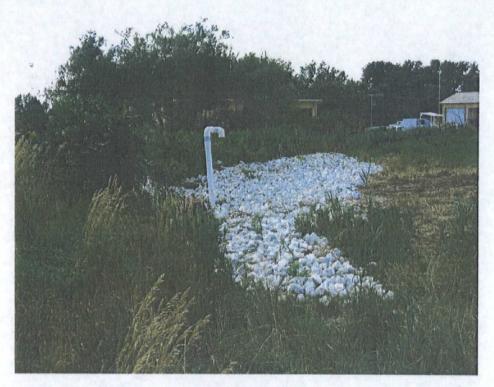
Photograph 41
Rock letdown and methane vent after improvements.

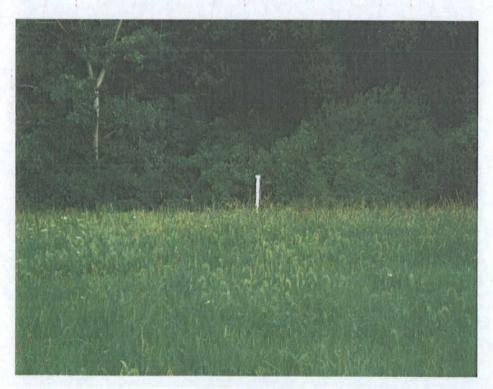
BMI field observation indicates that there are 18 methane gas vents, which were subsequently numbered (for discussion purposes) counterclockwise starting at the leachate collection system east manhole. Methane vents 6, 7, 8, 10, 11, 12, 13, and 17 appeared to be lacking parts of their upper risers and/or rain caps. Gradel site reconnaissance activities found the missing upper risers and rain caps scattered about the landfill cap. Subsequently, a Gradel employee repaired methane vents 6, 7, 8, 10, 11, 12, 13, and 17 by reattaching the upper risers and/or rain caps on July 28, 2011.

Photograph 42 Methane vent after improvements (typical).

The methane gas vents were repaired to be as good as originally designed.
